Technical Note N-1424

INSPECTION OF OBJECTS RETRIEVED FROM THE DEEP OCEAN - AUTEC
ACOUSTIC ARRAY

J. F. Jenkins

February 1976

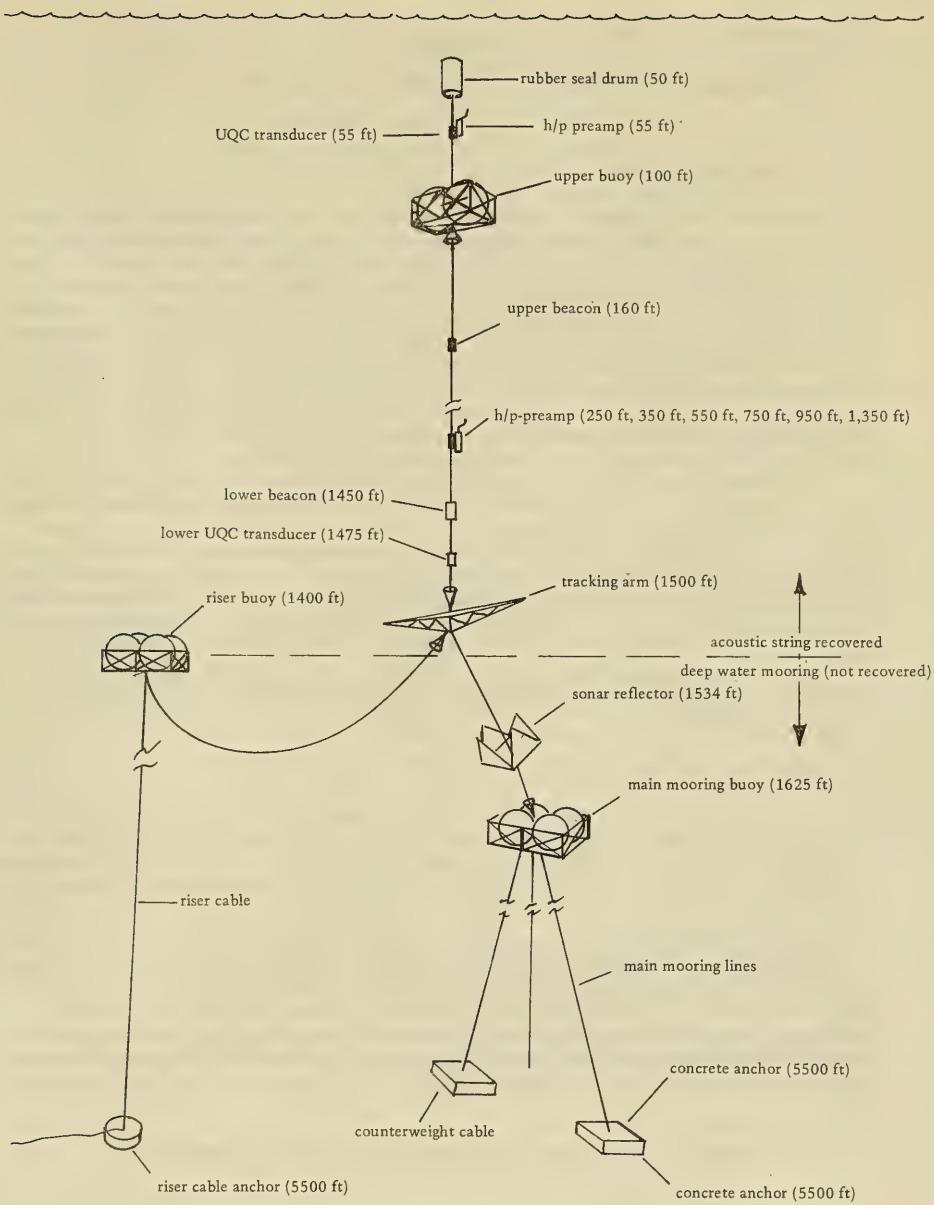
Figure 1. AUTEC acoustic array.

As shown in Figure 1, the AUTEK acoustic array emplaced in 1962, consists of two main parts: the deep water mooring and the acoustic string. The system was so designed that the acoustic string could be retrieved and replaced without retrieving the deep water mooring. In December 1973 the upper buoy was found washed ashore. The 21-quad cable used in the acoustic string had parted at or near the cable termination on the second termination below the main buoy. It was determined during an inspection of the failed array using a manned submersible that the acoustic string had fallen on the main mooring buoy. It was then planned to retrieve the acoustic string by attaching to the bitter end of the failed 21-quad cable, raising the bitter end to the surface, and then retrieving the acoustic string in a normal manner. It was planned to replace the failed acoustic string with a new unit if the condition of the deep water mooring, as inferred from the condition of the failed acoustic string, could be expected to have a reasonable additional service life.
